**Flood Control Project Maintenance  
Levee Inspections**  
**LMA District Cover Sheet**  
**Spring 2019 Levee Inspection Results**

**Reclamation District No. 0900 West Sacramento**

**Levee Inspection Report By Mile - Spring 2019**

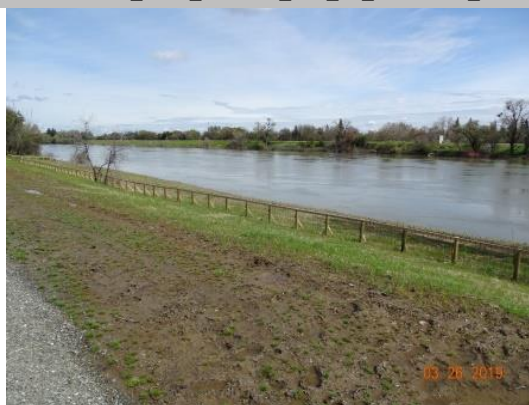
Photo 1 of 1 : SP\_2019\_RD0900\_230\_28\_20190327\_00022.jpg

LM Start	2.55	Rating **	A/W	Issue No.	28
LM End	2.64	Issue Type +	Ma	Location *	WS
Category	Supplemental			GPS Latitude/Longitude	
				Start	End
Item	2017 USACE Erosion Survey, DRAFT			38.551319 °	38.550090 °
				-121.514423 °	-121.513983 °
DWR ID	DWR_RD0900_01_s_2019_28				
Comment Code					
Inspector Comment					
2017 Site ID: SAC 56.5 R Status: Eroding 2017 Field Notes: Fresh toe erosion. Site History: 1997 - Low berm is contributing to erosion. Old timber pile dikes above water parallel to bank. The upstream mitigation low berm causes a flow separation at the site. 1999 - Some new localized erosion with less than one foot of bank retreat. 2000 - Some new erosion at the upstream end. Fat toe deposits at toe. 2003 - Some new erosion upstream, but have a wide berm. 2011 - Minor new erosion at toe. Spring 2019 DWR Inspection: Erosion was repaired.

View looking upstream at repaired erosion site. Spring 2019

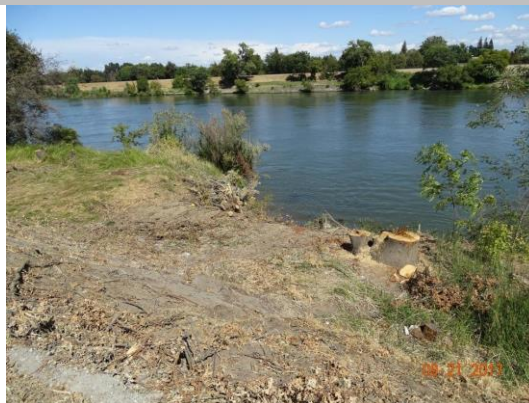
Photo 1 of 2 : SP\_2019\_RD0900\_230\_57\_20190307\_00010.jpg

LM Start	2.57	Rating **	A/W	Issue No.	57
LM End	2.57	Issue Type +	Ob	Location *	WS
Category	Earthen Levee			GPS Latitude/Longitude	
				Start	End
Item	Erosion / Bank Caving			38.550965 °	38.550965 °
				-121.514795 °	-121.514795 °
DWR ID	DWR_RD0900_01_f_2017_57				
Comment Code					
E1 : Note and monitor erosion site.					
Inspector Comment					
The contractor (AECOM) is constructing the setback levee, and they cut down the trees in this area. Levee is repaired.

View of the existing erosion site on the waterside berm of the levee. Fall 2017

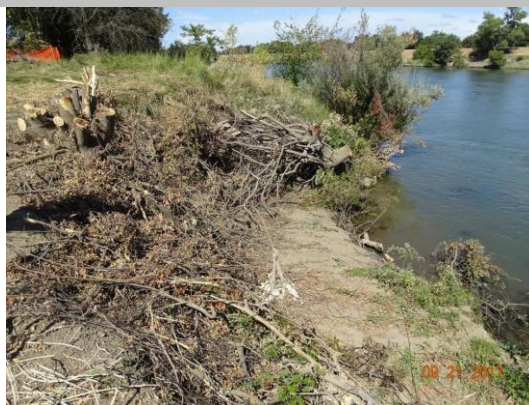
Photo 2 of 2 : SP\_2019\_RD0900\_230\_57\_20190307\_00011.jpg

The contractor is planning on placing riprap in this area. This picture was taken from the waterside berm of the levee looking upstream. Fall 2017

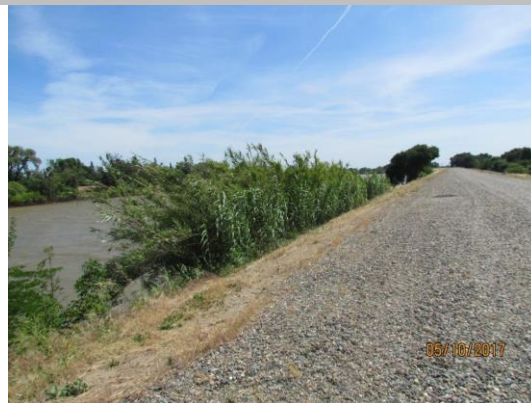
Photo 1 of 1 : SP\_2019\_RD0900\_230\_59\_20190307\_00012.jpg

View of the arundo on the waterside of the levee during spring 2017 inspection.

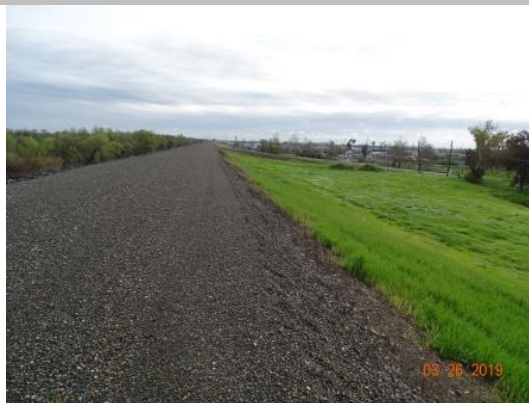
Photo 1 of 1 : SP\_2019\_RD0900\_231\_41\_20190327\_00051.jpg

View of well-maintained landside vegetation. Spring 2019

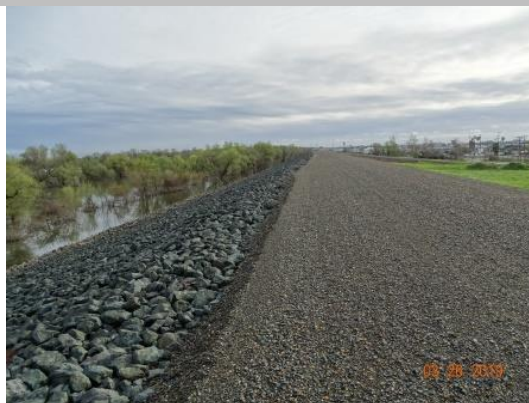
Photo 1 of 1 : SP\_2019\_RD0900\_231\_42\_20190327\_00052.jpg

LM Start	0.00	Rating **	A	Issue No.	42
LM End	0.87	Issue Type +	Ma	Location *	WS
Category	Earthen Levee			GPS Latitude/Longitude	
				Start	End
Item	Vegetation			38.582085 °	38.574708 °
				-121.567899 °	-121.580222 °
DWR ID	DWR_RD0900_02_s_2019_42				
Comment Code					
V1 : Control annual grass and weeds on the levee slopes and easements.					
Inspector Comment					
Annual vegetation is well-maintained.

View of well-maintained waterside vegetation. Spring 2019

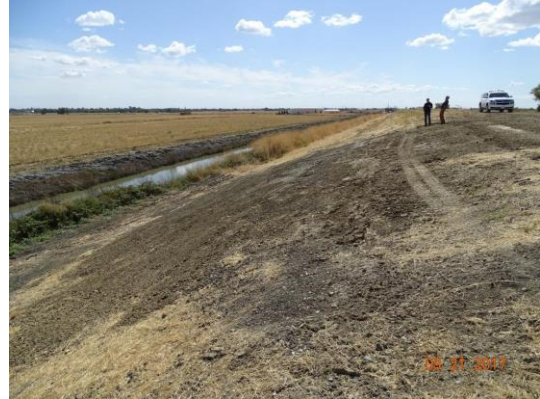
Photo 8 of 8 : SP\_2019\_RD0900\_231\_40\_20190307\_00011.jpg

View of a repaired slope instability site on the landside of the levee looking downstream on levee mile 4.63 (38.52111, -121.582148). Fall 2017

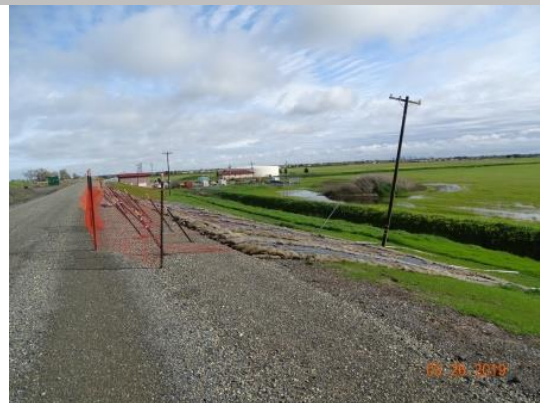
Photo 1 of 2 : SP\_2019\_RD0900\_231\_54\_20190327\_00057.jpg

View looking north at ~80' landside slip that LMA mitigated. Spring 2019

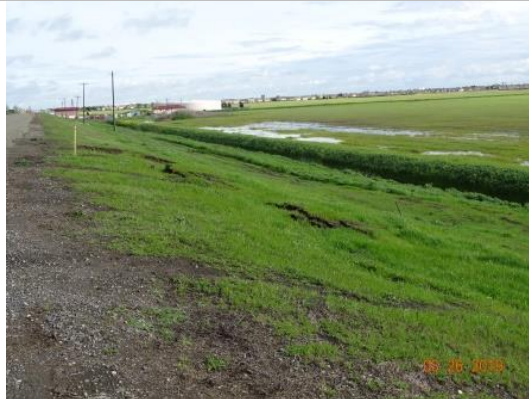
Photo 1 of 2 : SP\_2019\_RD0900\_231\_55\_20190327\_00054.jpg

View looking northward at 100'-long slip that is roughly 2-3' deep. Spring 2019

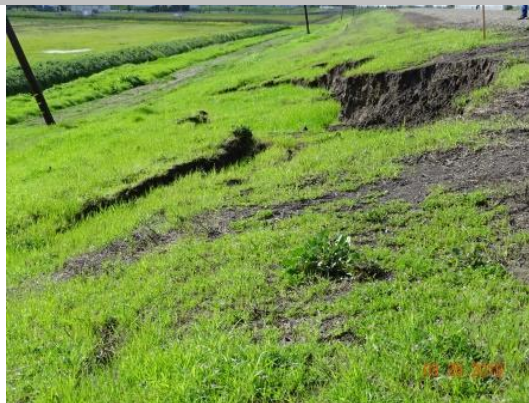
Photo 2 of 2 : SP\_2019\_RD0900\_231\_55\_20190327\_00056.jpg

View looking southward at 100'-long slip that is roughly 2-3' deep. Spring 2019
